**"EPA's Bristol Bay Watershed Assessment —
A Factual Review of a Hypothetical Scenario"**

QUESTIONS FOR THE RECORD

ATTACHMENT A.:

PHOTOGRAPHS AND DESCRIPTIONS OF ENVIRONMENTAL HARMS

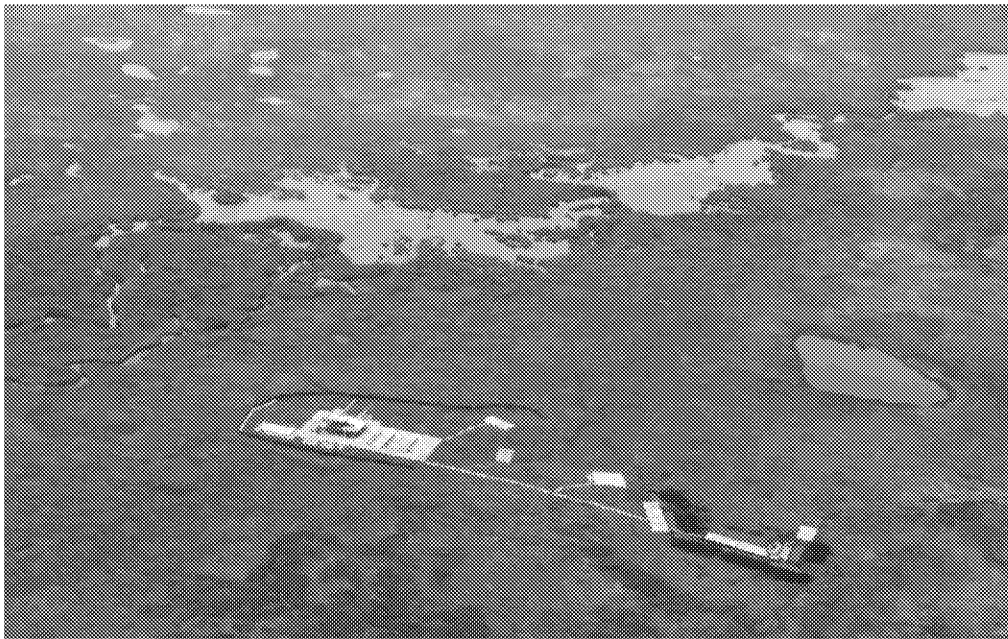
Figure 1. Aerial view of PLP drill rig platform located adjacent to an anadromous stream with a beaver dam in it. This stream flows south into Frying Pan Lake and then into the South Fork of the Koktuli and into the Nushagak River. Photo shows the platform situated on wetland tundra prior to installation of the heavy drill rig. Right-hand side of photo shows six excavated holes used for settling ponds. Clear ground water has seeped into these holes, which are later filled with drilling muds and cuttings (see Figures 2-4). Photographer Rick Halford, August 1, 2011.

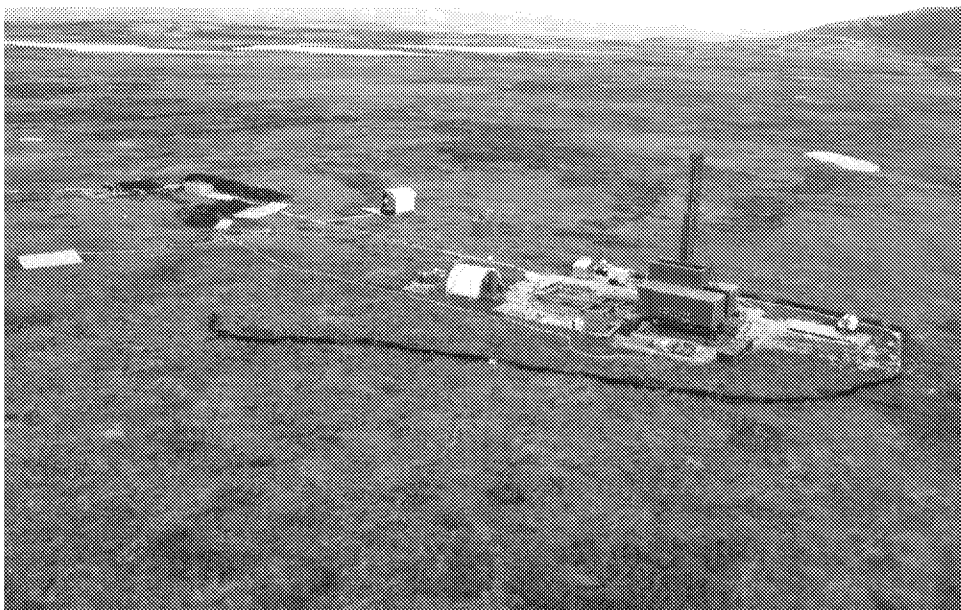
Figure 2. Aerial view of the PLP drill rig platform from Figure 1, one month later. With the heavy drill rig now installed, the platform and silt fences have been pushed down into the tundra. Grey water from the drilling muds and operation surrounds the silt fences on tundra adjacent to the anadromous stream, as seen on the right-hand side of the photo. Photographer Rick Halford, September 1, 2011.

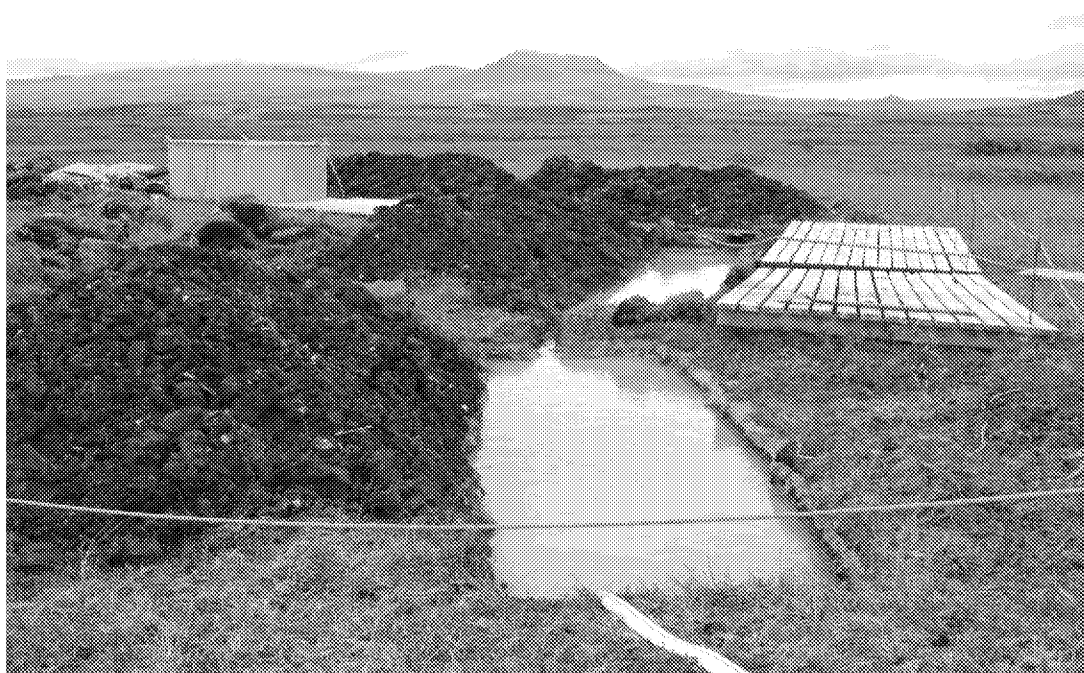
Figure 3. Excavated settling ponds (sumps) located at the PLP rig platform shown in Figures 1 and 2. Sumps are approximately 5' deep, 8' wide, and 10' long. Operation is pumping drilling muds (such as bentonite) and drilling fluids and additives into the sumps. The drilling muds and fluids are coating the walls of the holes. Photographer Rick Halford, September 1, 2011.

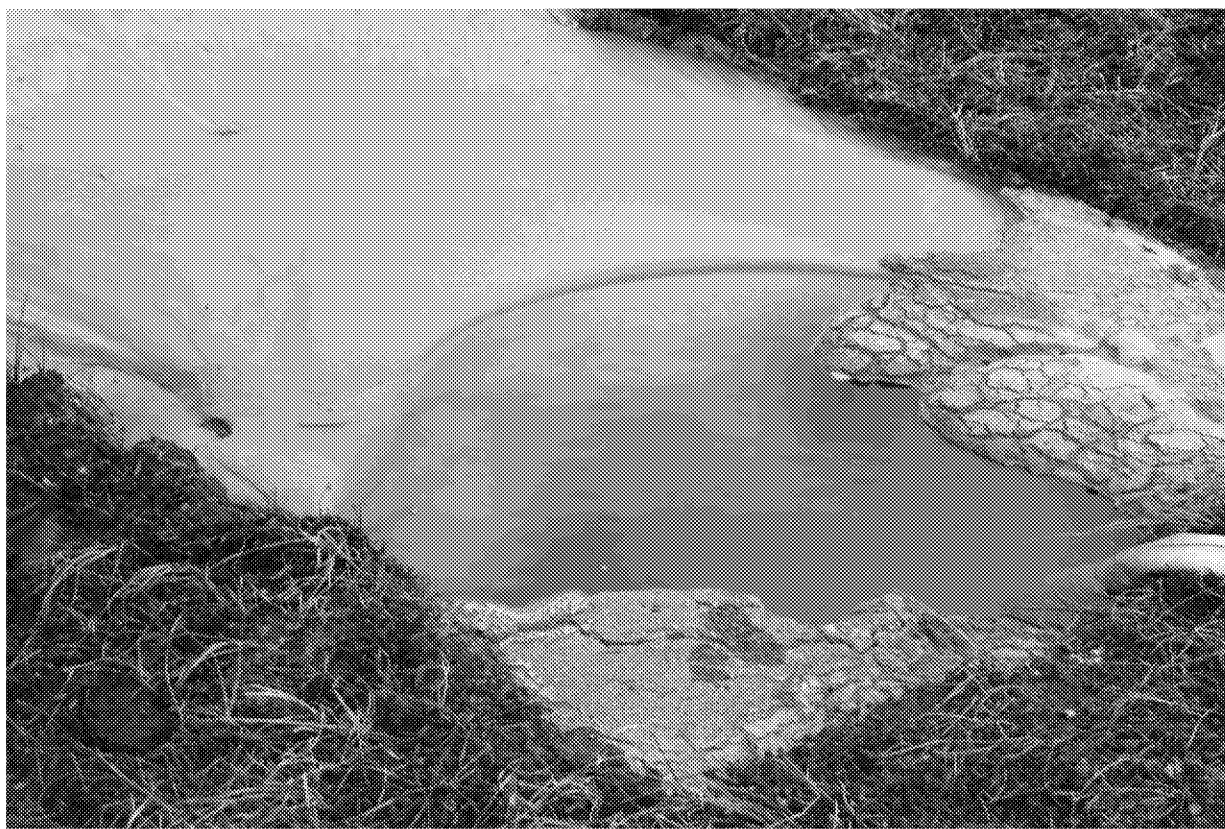
Figure 4. Excavated sump located at the PLP rig platform shown in Figures 1 and 2, now filled with drilling muds, fluids, additives, and drill cuttings. These sumps were later filled in with soil and left behind. Photographer Rick Halford, October 2011.

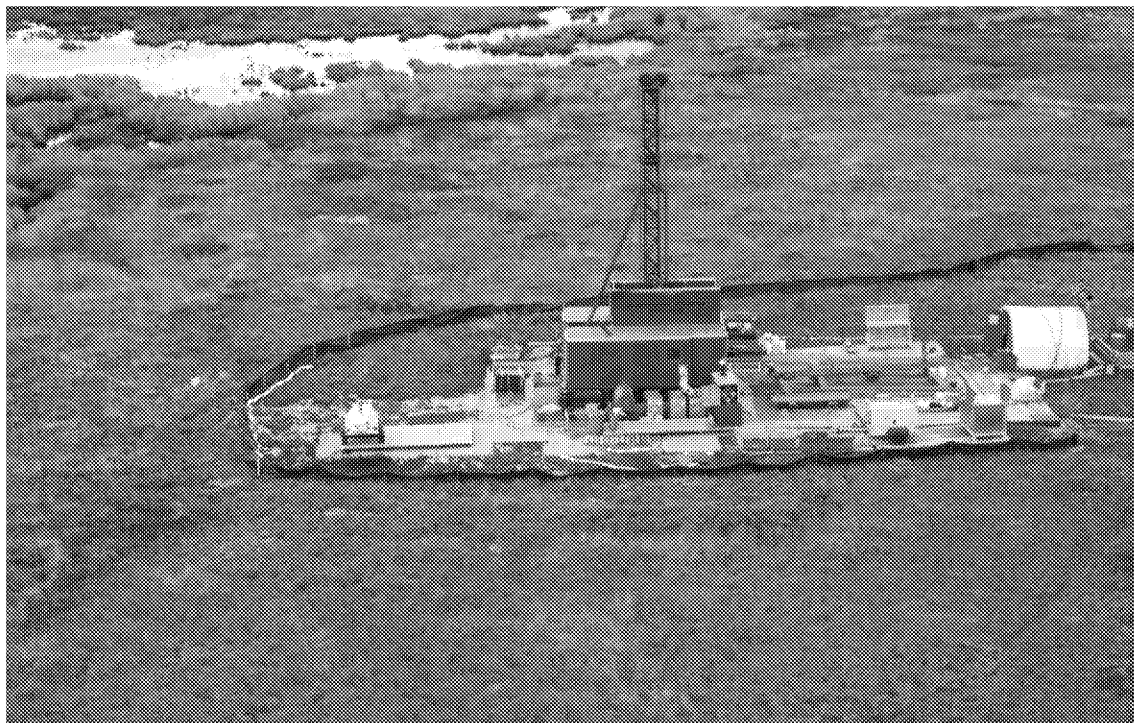
Figure 5. Aerial view of the PLP drill rig platform from Figures 1 and 2. To the left of the drill rig there is visible grey water settling on the tundra from the drilling muds and operation. This operation occurred close to an anadromous stream (top of photo). Silt fences and operation platform have settled into the tundra due to the vibrations from drilling.

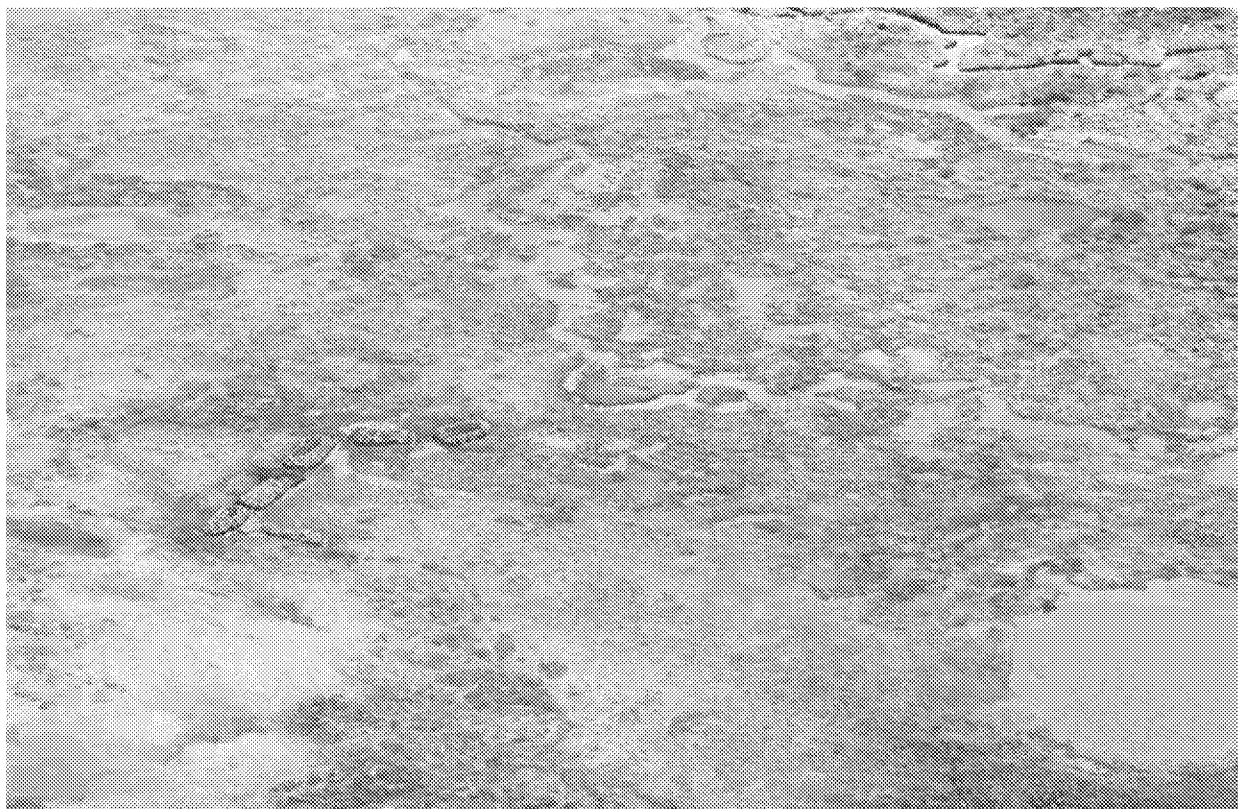
Figure 6. Aerial view of PLP drill site shown in Figures 1-5. Photo is taken after the site was supposedly remediated. The six mounds on the tundra are the sumps filled with cuttings, drilling muds, and excavated soil. The grass under the operations platform is still matted down. The area is surrounded by wetlands. Photographer Rick Halford, June 2012.

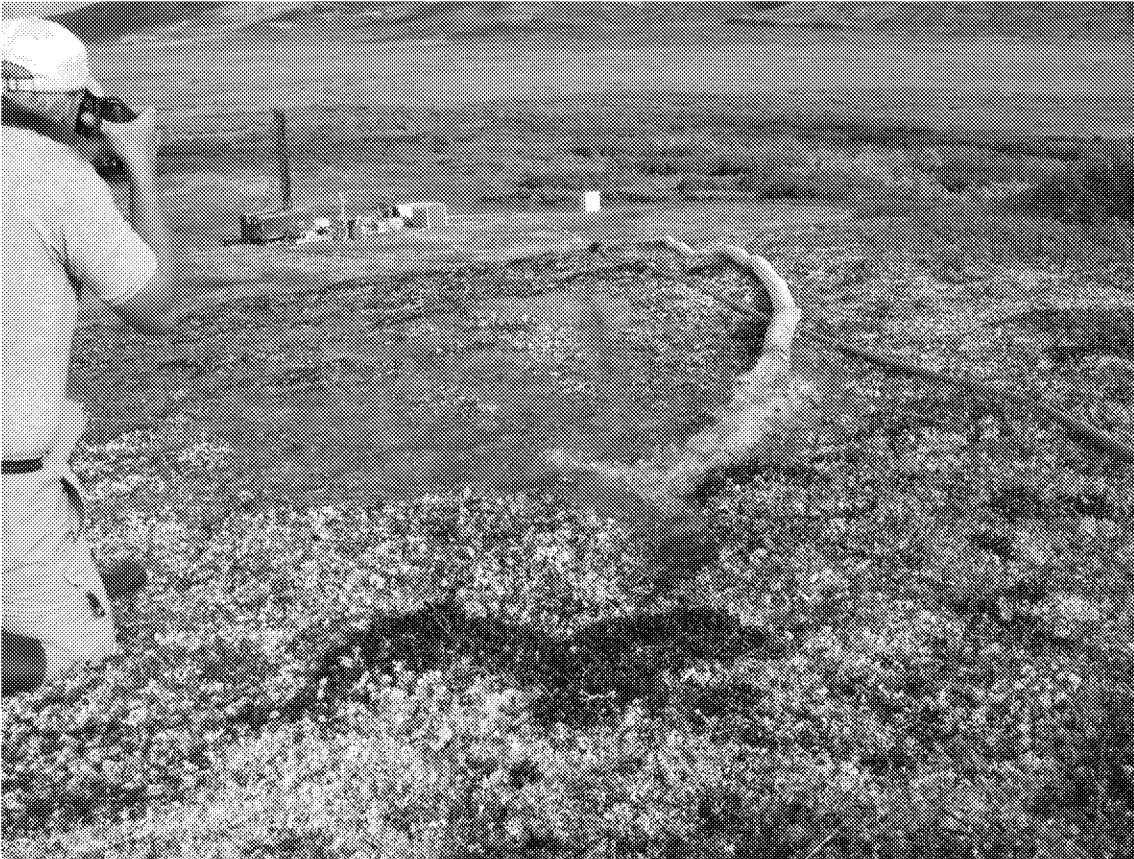
Figure 7. An exploratory drill rig pumps water containing drilling muds and fluids out of settling ponds, depositing the fluid on upland tundra vegetation. This operating drill rig is also located close to PLP's biggest basecamp north of Frying Pan Lake. Photographer Rick Halford, September 2009.

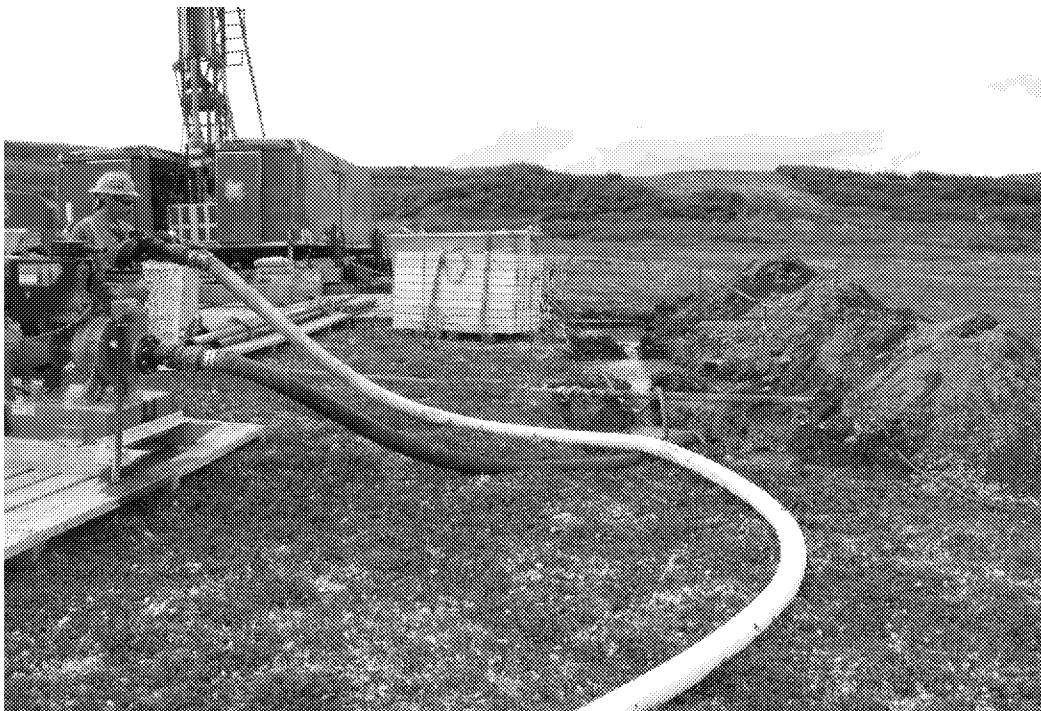
Figure 8. PLP employees pumping water containing drilling muds and fluids out of the sumps through a hose to be deposited on upland tundra (as seen in Figure 7). Photographer Rick Halford, September 2009.

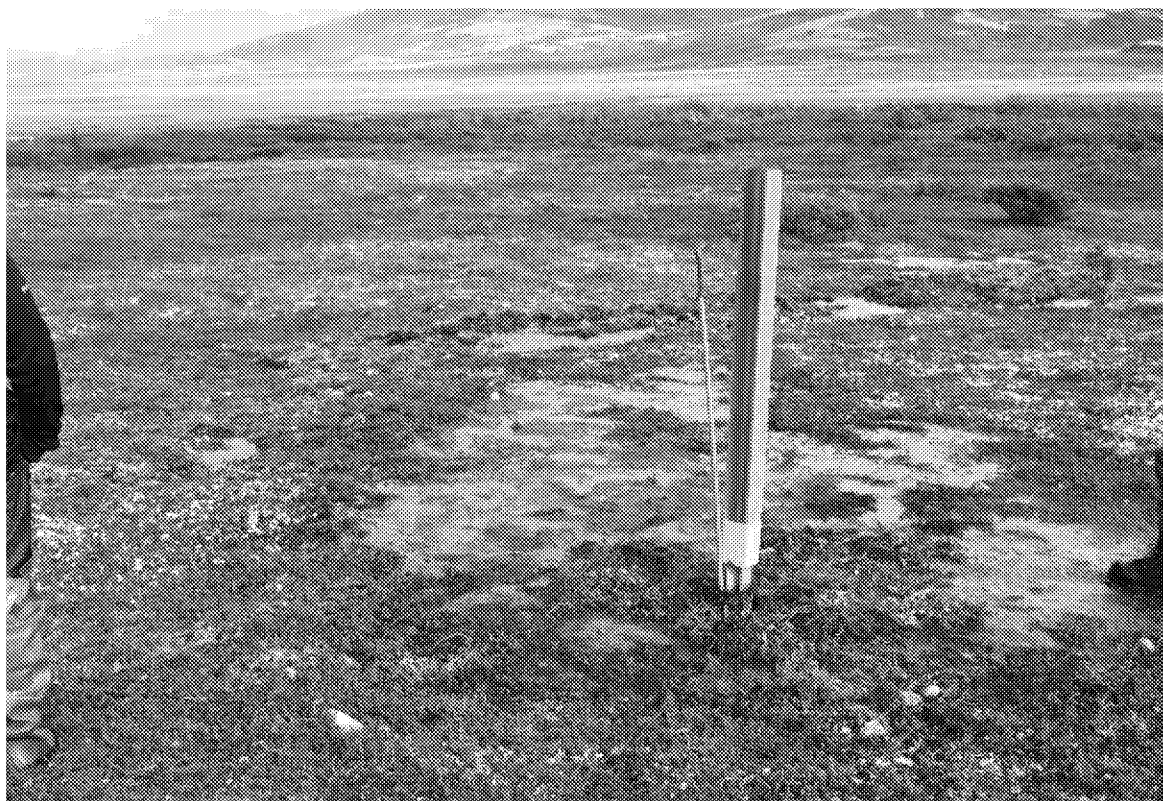
Figure 9. An uncapped well hole from the drill rig shown in Figures 8-9, three years after operations ceased. This well hole was not properly plugged, leading to artesian flow with groundwater and minerals leaching on the site. This flow occurred for three years before PLP pumped high pressure concrete and materials into the well hole to stop the artesian flow.

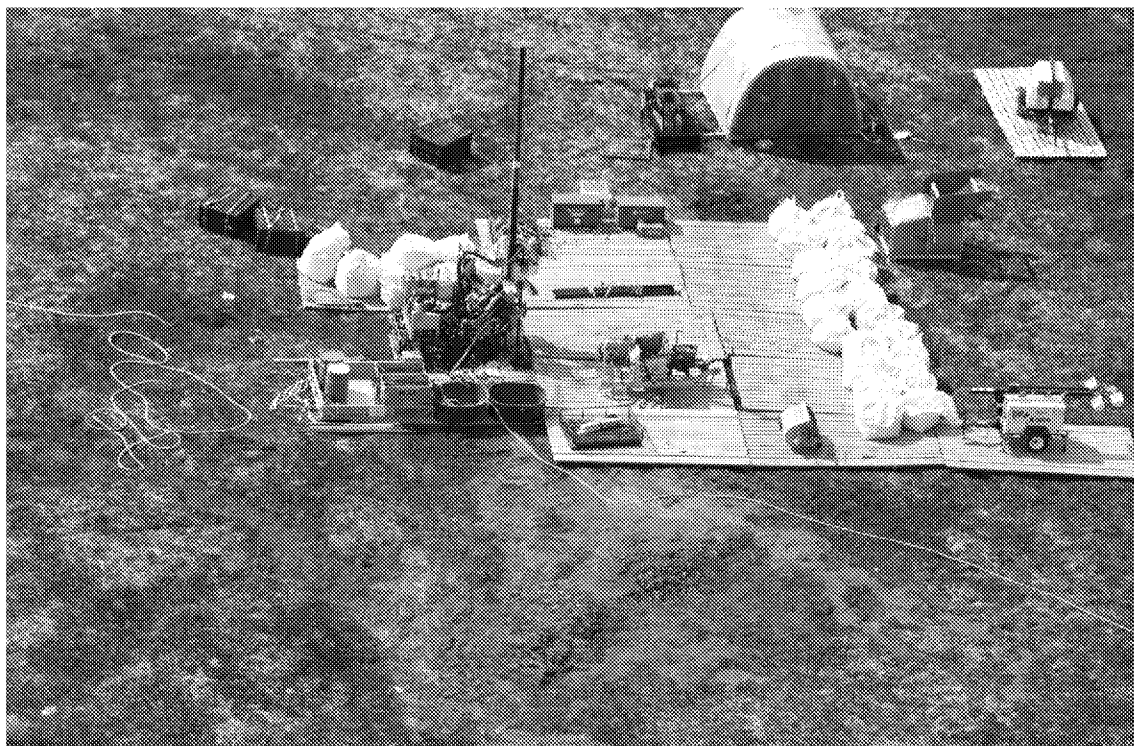
Figure 10. Aerial view of the well shown in Figures 7-9. The orange stain on the tundra is from water and minerals spilling from the well hole. Photographer Rick Halford, June 25, 2012.
